Leakage at Upper Mun Dam

Nibondh Saihom, Ruongrit Ammawat, Mondhian Kangsasitiam
and Thanu Harnpattanpanich
Royal Irrigation Department, Thailand

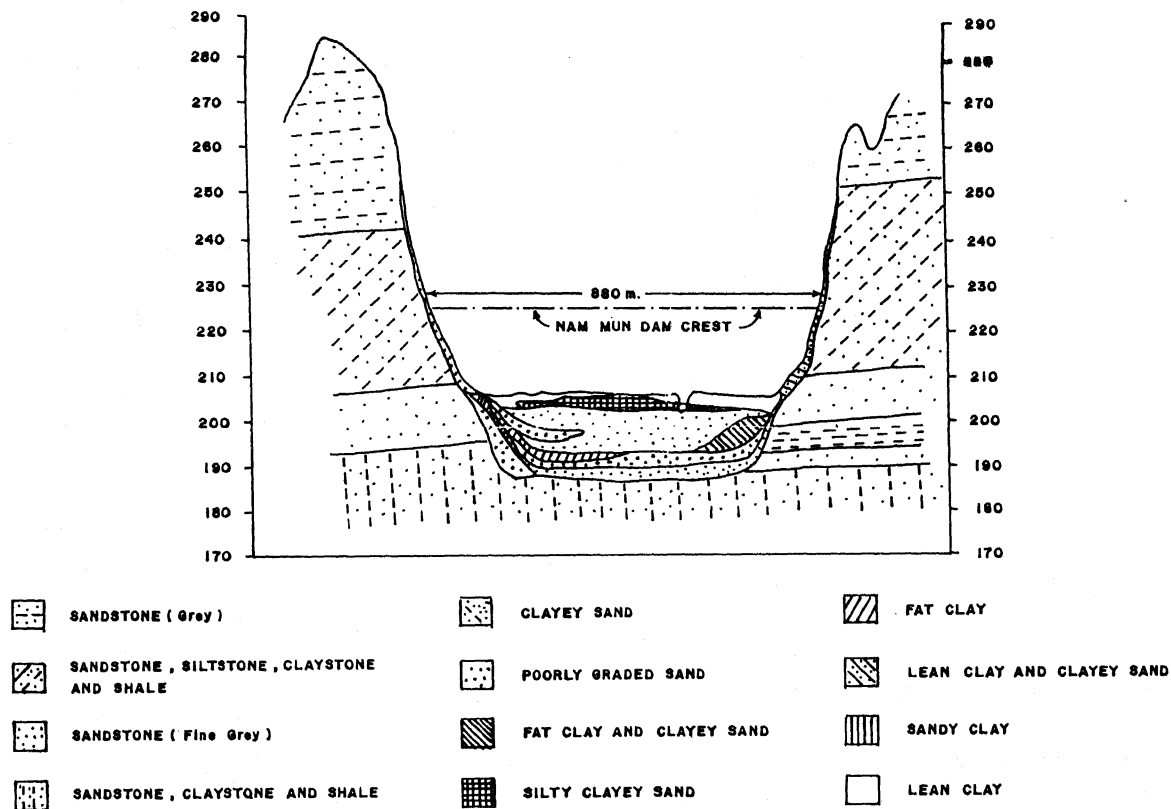
Fig. 2 Geologic section along center line of the dam⁽²⁾

The dam was founded on alluvium deposits, overlying rocks of Khorat Group comprising sandstones, siltstones, and mudstones. These rocks are exposed on the hills on either side of the valley on the dam abutments. The alluvial deposits, as much as 19 meter thick, primarily consist of clay, silty sand and sandy silt soils of low plasticity. Fig.2 depicts the geologic section along the center line of the dam.

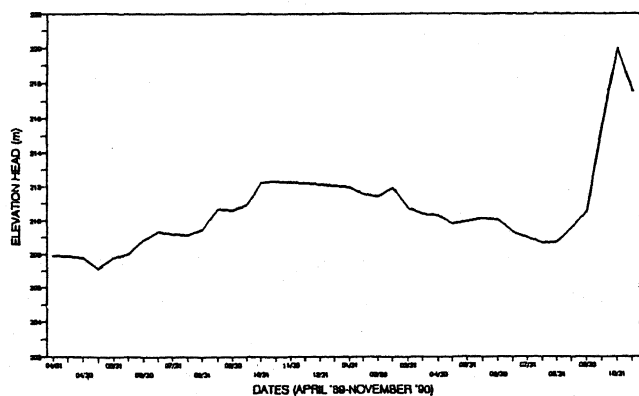
Fig. 4 Plot of Reservoir Elevation
VS. time before incident

Timelines of reservoir elevations, since the commissioning of the dam until immediately following the failure incident, is shown in Fig. 4. During 1989 wet season the reservoir has only reached elevation 213 m. As may be observed from October 4 to October 23, 1990 the reservoir elevation rose rapidly from 210.79 m. to 220.35 m. as a consequence of two consecutive depression storms.

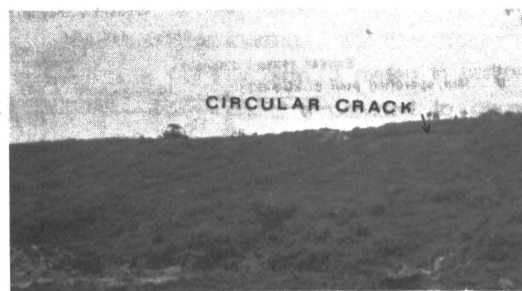
Fig. 5 Circular crack at leakage STA. 0+856

October 22, a leakage appeared at the toe of the downstream slope at STA 0+856. The hole was approximately 15 cm. in diameter. The leakage water was clouded with sediment. Rock and aggregate were dumped into the hole in order to stop the boiling. However, the attempt was not succeeded. The leakage amount increased and the hole enlarged throughout that night.

October 26, early in the morning, the quantity of the leakage increased again and reached its peak of about 6 m³/sec. at around 11 a.m. At 8.30 a.m. a tension crack was observed at the downstream slope from STA 0+800 to STA 0+850, just above the leakage point, approximately 3 m. below the crest. Before 9 a.m. small cracks appeared on the crest. The cracks on the slope grew and developed to a complete circular failure. By 10 a.m. movement of the sliding earth was observed (Fig.5). Shortly before 1 p.m. a loud cracking sound occurred for about 15 minutes as the embankment collapsed and caved-in. With the continuing efforts in plugging the dam, in the late evening the leakage decreased to about 1 m³/sec.

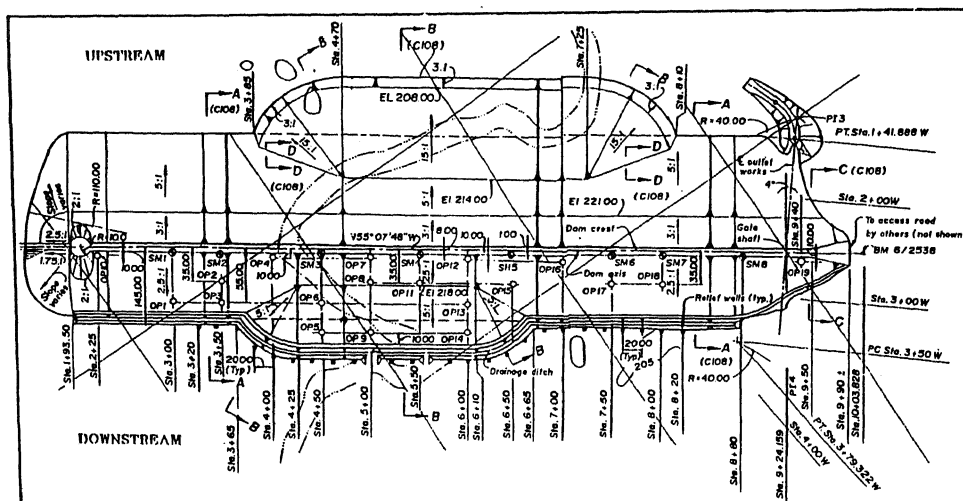
Fig. 6 Plan of Mun Bon Dam

A number of open-ended standpipe piezometers had been installed in the embankment and foundation at various location and depth to measure pore pressure (Fig.6). Reading had been made daily since April 1989.

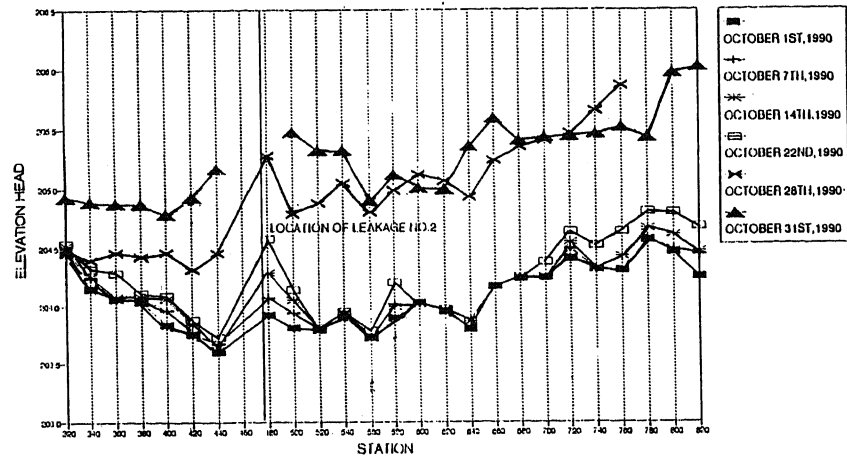
Fig. 7 Relief well record data

Relief wells were provided along the toe of the dam, at intervals of 20 m. to various depth, from chainage STA 0+320 to STA 0+820 (Fig.7), as an under seepage control measure to alleviate the uplift and seepage forces in the foundation.

A monthly assessment of the performance of the relief well system (April 1989 to October 1990), achieved by plotting representative relief well data across a longitudinal section of the dam, indicated that they were functioning. During rapid filling of the reservoir in October 1990, a substantial increase in relief well level was observed at STA 0+480 (beside location of leakage), (see Fig.7), indicating high seepage through the foundation in the vicinity of this location. The aforesaid observation confirmed results of the geological investigation, which indicated the presence of permeable members that were hydraulically connected across the dam foundation at the leakage locations. Due to the absence of relief wells beyond STA 0+856, it was not possible to determine if similar large underseepage existed in the foundation at this location. However, relief wells in the vicinity at STA 0+800 and STA 0+820 also indicated large underseepage.

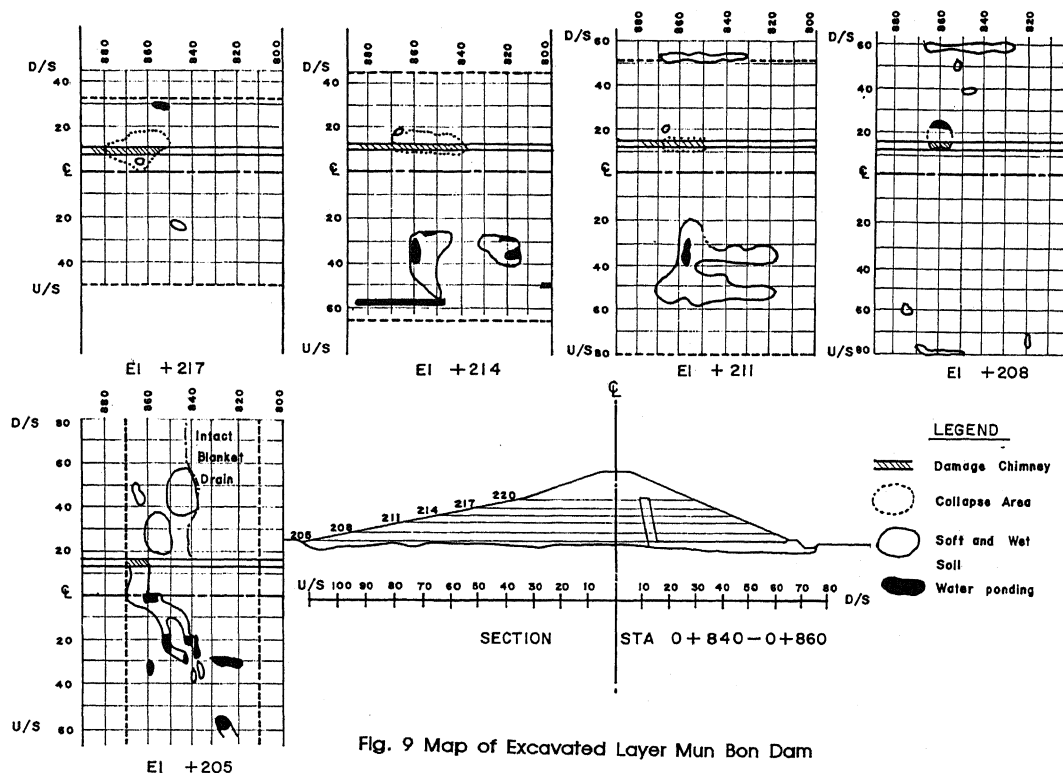
Fig. 9 Map of Excavated Layer Mun Bon Dam

The result of this excavation was presented in maps as shown in Fig.9. In the figure, maps for each of exposed surfaces of ELV +217, +214, +211, +208 and +205 m. were shown. They indicated the area where wet and soft soil layer, water ponding, and collapse of the embankment were noticed.

From these maps, even though the wet layer and water ponding were found at almost every depth, they were concentrated in the upstream and downstream part of the dam. Care had been made to find the connection of these wet layers from upstream to downstream. Trenches were always excavated just downstream of any wet layers. However, these wet layers would somehow, terminate within a short distance downstream. The embankment downstream of the wet layers gradually changed into intact materials as the excavation was progressed laterally downstream. Overlay map of each elevation, the wet layers and water ponding zones seem to be connected in vertical direction. The only connection from upstream to downstream was at elevation near the foundation, i.e. closed to Elv +205 m.

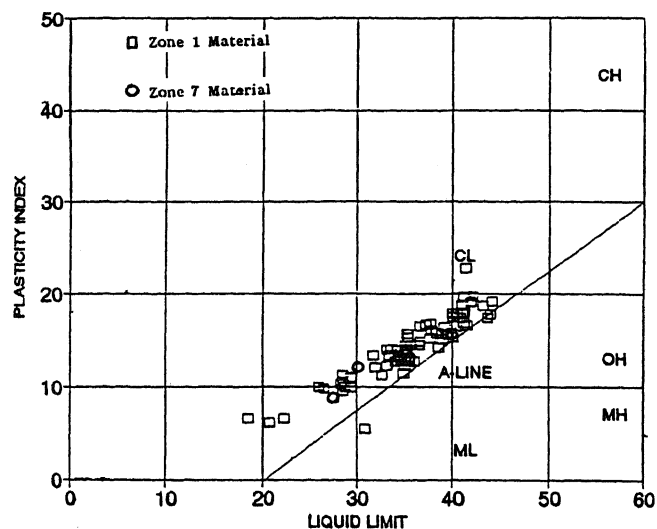
Fig. 10 Plasticity chart of Embankment soil

The Zone 1 material, constituting the impervious fill comprised more than half of the volume of the dam embankment. The majority of soil for Zone 1 was classified as CL (Unified Soil Classification System) or inorganic silty-clay of low to medium plasticity, as indicated by the cluster of points above the Casagrande A-line in the plot of liquid limit against plasticity index (See Fig.10). The results of grain size distribution analyses informed that the mean median grain size (D_{50}) was 0.01 mm. and the mean percent clay size content (less than 0.005 mm.) was 44.3%. Fig.11 shows the grain size

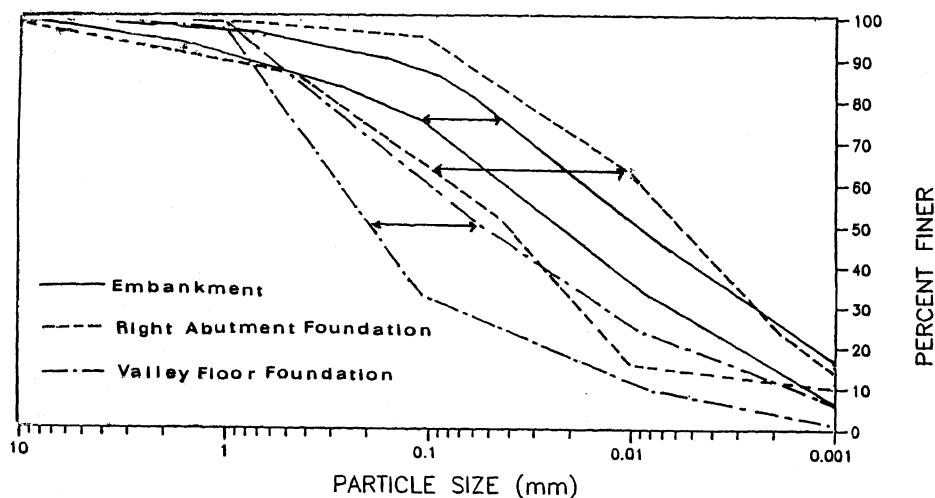
Fig. 11 Grain Size Distribution Range of Embankment and Foundation Materials

distribution range of as-placed Zone 1 material. The material possessed intermediate resistance to piping and high susceptibility to cracking.

Results of post-failure gradation tests on foundation materials beneath the right abutment (See Fig.11) were compared with the gradation of as-placed material. The piping and permeability criteria for filter design were satisfied. Upon performing similar comparisons for left abutment, it was discovered that the filter criteria were satisfied for both foundation material.

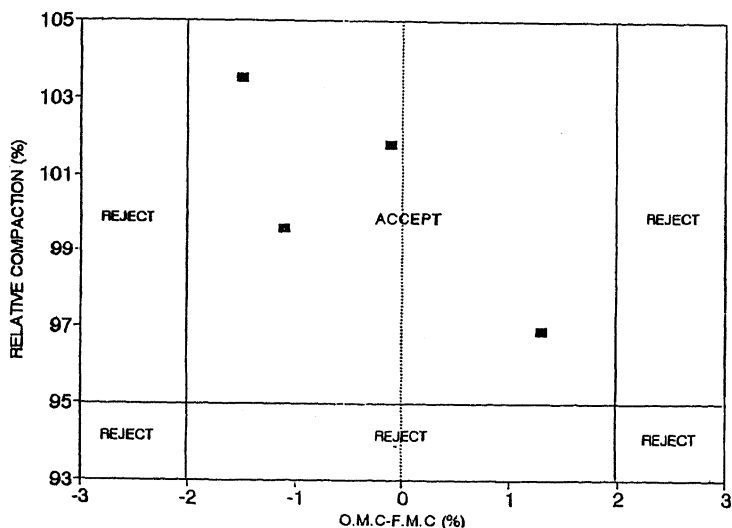
Fig. 12 Plot of Relative Compaction of Zone 1 Material

Fig.12, comparison of laboratory Proctor density and optimum moisture determination with field density and moisture determination, shows that most materials are compacted on the wet side of the optimum moisture

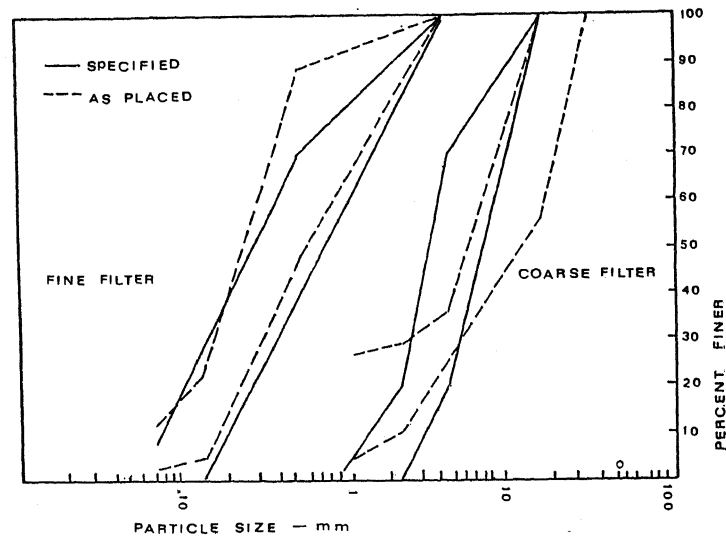
Fig. 13 Gradation Curve for Filter Material

The results of gradation test on samples of the as-placed sand filter (Zone 2), obtained at STA 0+480, are indicated in Fig.13.

It is evident that wherein grain size distribution of the as-placed sand filter is a uniform fine sand, that gradation is slightly off the specification limits.

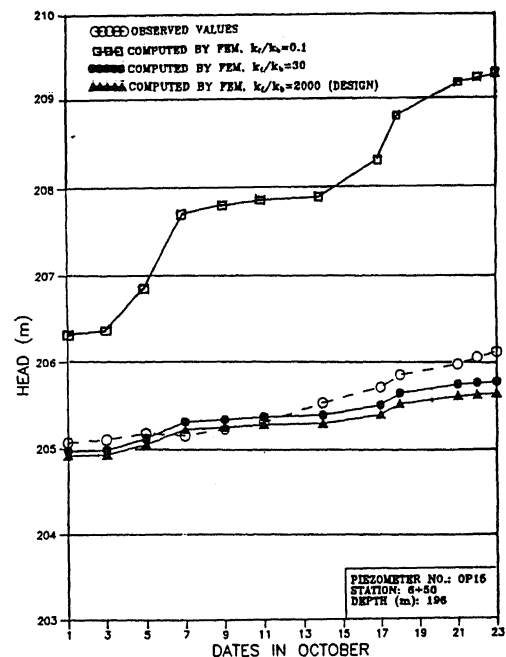
Fig. 14 Comparison between Observed and FEM Pressure Head In Foundation

The permeability of the horizontal blanket drain was established iteratively by matching the calculated head with the observed head during the days of the incident. With these assumptions, the analyses showed good agreement within 1 meter difference between calculated and observed heads for most of the piezometer, when the coefficient of permeability of the horizontal blanket drain was 30 times more permeable than that of foundation soil. In other analysis, using the design value for coefficient of permeability for the horizontal blanket drain of 2 cm/sec, which was 2,000 times more permeable than the foundation, yielded only slightly lower head. While in the analysis where the blanket drain was assumed permeability value of 10 times less than the foundation, simulated the clogging of drain, showed a much larger prediction of head in the foundation (See Fig.14). This analysis indicated that no clogging of blanket drain had occurred.
